Technical Notification

Document no. 20050926

Sailor RT5022 VHF DSC

Incorrect factory setting of power output in **DSC** and **Distress**-transmission.

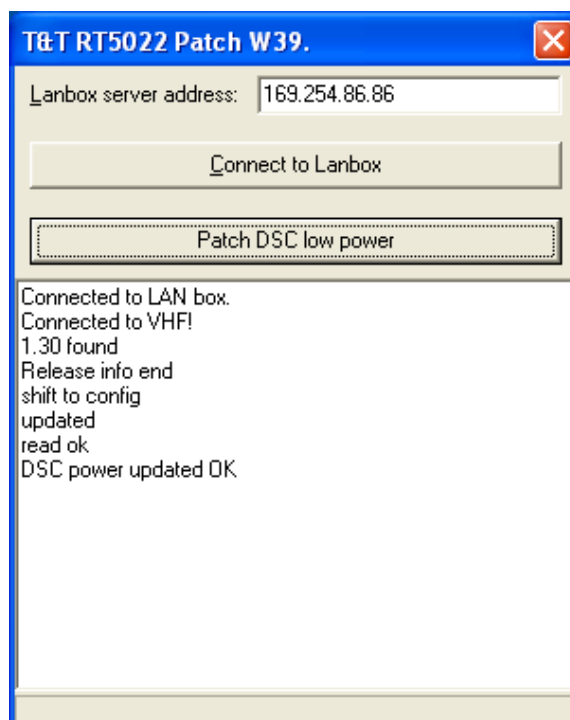
6) Now press **Patch DSC low power**. The patch is now executed. The detail progress is reported in the window. A successful fix will show the following transcript:

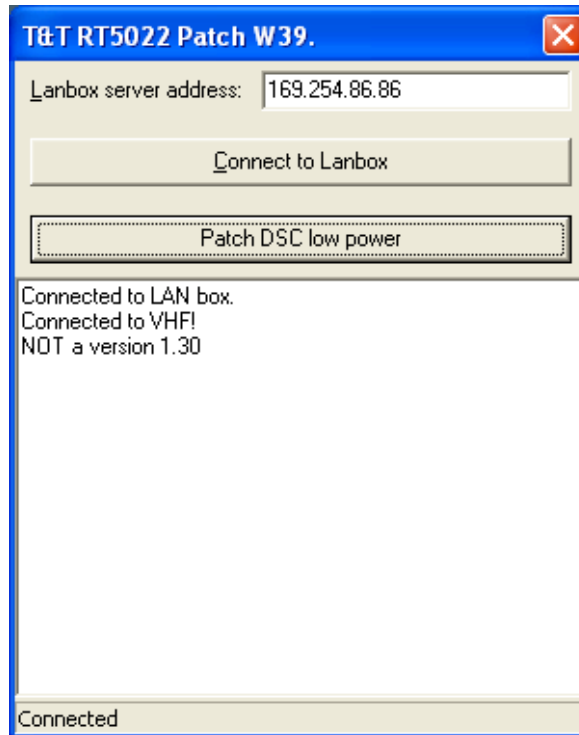
If the program fix is applied to radios with software different from Main Release 1.30 the following transcript might be seen, showing the fix is not needed on this version.
