Repair Instruction

Document number: 97-131251

SAILOR RT5022 VHF DSC & RT5020 Duplex VHF DSC Replacement of capacitor C83

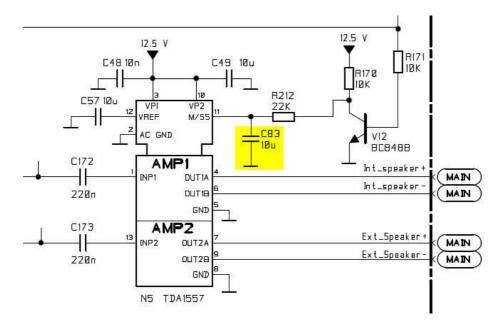
Following symptoms may be an indication of a defective C83 capacitor:

- Audio volume in internal speaker fades out. Turning the radio off and then back on may temporarily restore audio function to normal.
- No audio in internal speaker.
- **Note**: There may be other causes for a failure of audio in the radio and hence the replacement of the capacitor C83 may not always solve a problem with loss of/missing audio. If this proves to be the case the BaseBand PCB should be replaced and sent to Thrane & Thrane A/S for repair.

Schematic diagram showing the audio circuitry comprising capacitor C83

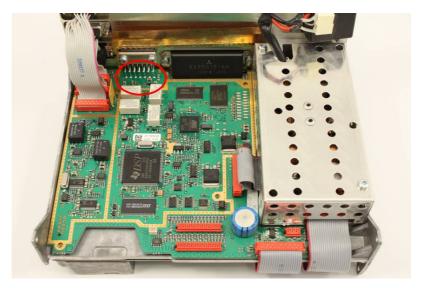
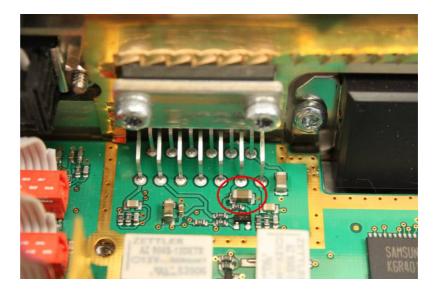
Step 1: Locate Capacitor C83 on the BaseBand PCB.

Remove C83 from the BaseBand PCB using e.g. following technique:

Remove the capacitor using a regular soldering iron tip as follows: heat one side/pin of the capacitor until the solder is melting and then quickly move to heat the other side/pin until the solder here is melting. Keep alternating this heating process between the two sides/pins 5-10 seconds until sufficient heat has build up on each side of the capacitor, allowing it to easily slide off the solder pads.
